AFWAL-TR-84-3115

ACCELERATED CORROSION TESTING OF GRAPHITE/EPOXY COMPOSITES AND
ALUMINUM ALLOY MECHANICALLY-FASTENED JOINTS

June 1985

Final Report for Period May 1980 - December 1984

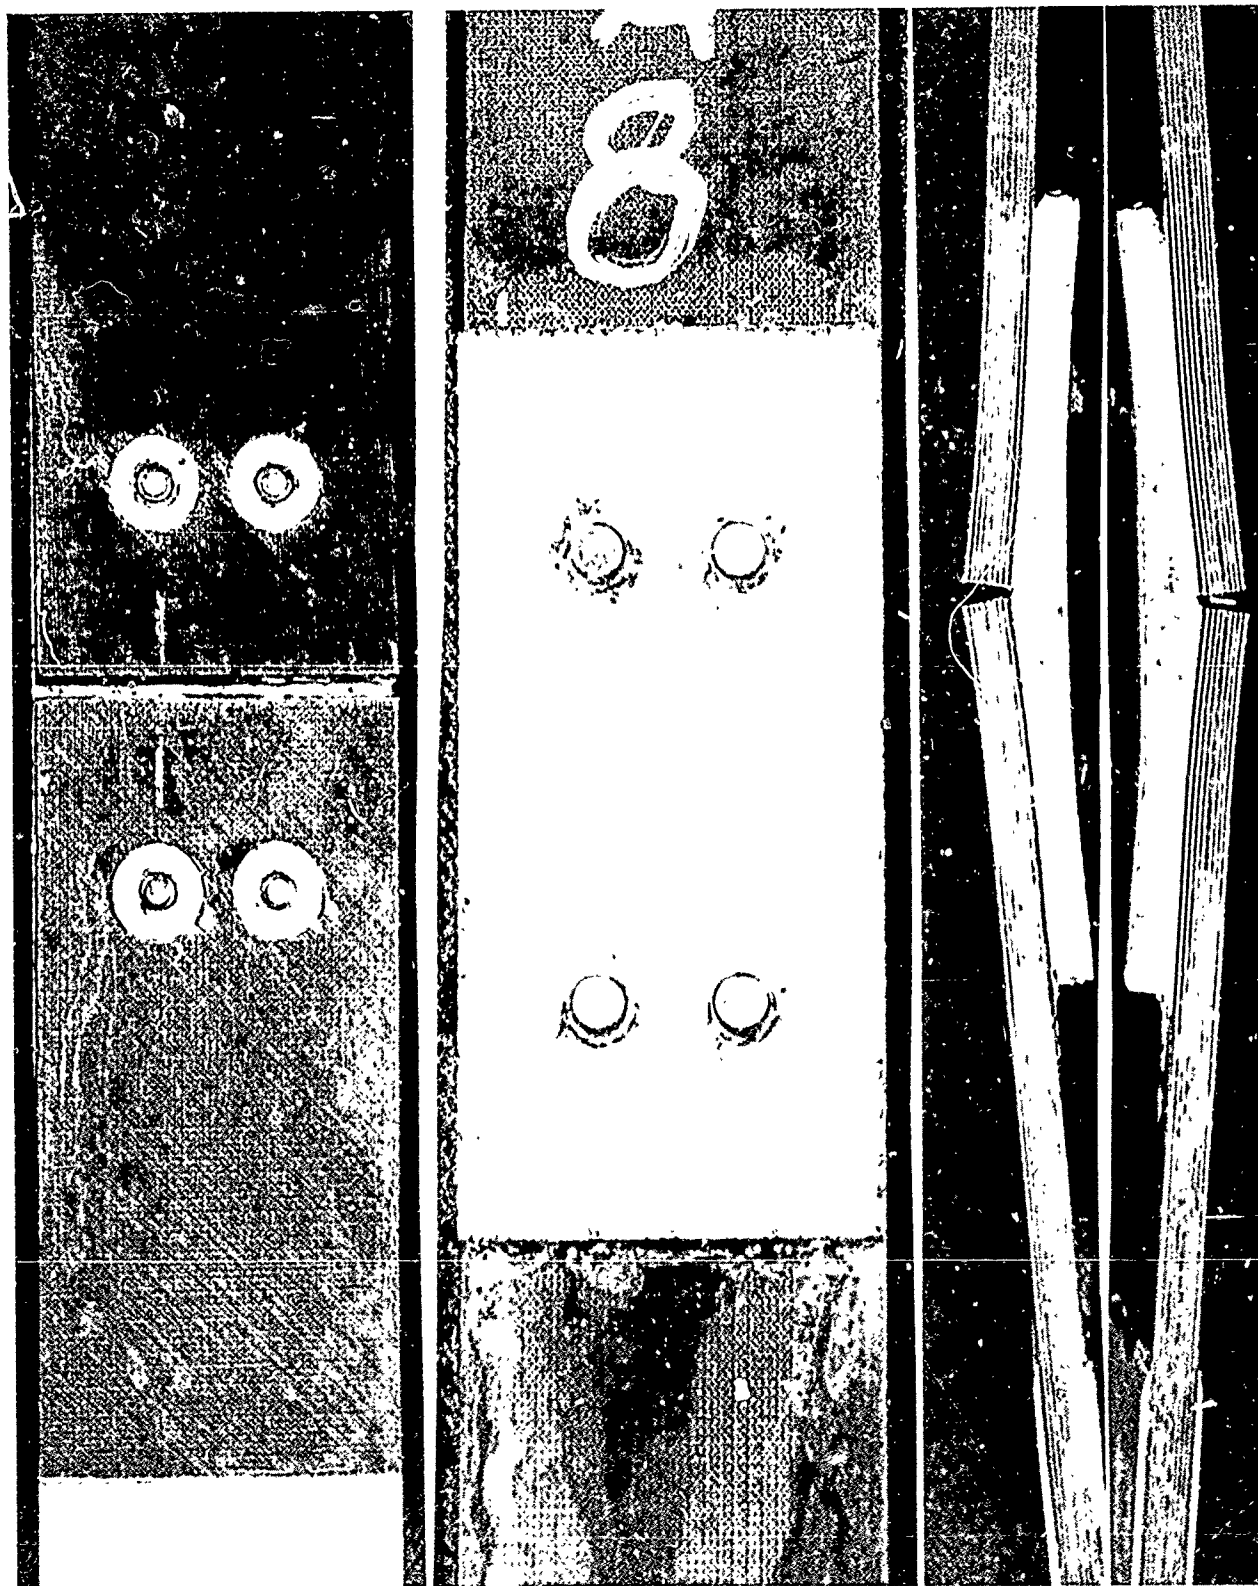
Figure 4. Unprotected Graphite/Epoxy and Aluminum Alloy
Lap-Joint Fastened with A-286 CRES Fasteners
After Two Corrosion Cycles

The effect of the exposure to two corrosion cycles without the fatigue test sequence for the unprotected samples is shown in Figure 4 for the joints with A-286 CRES fasteners. The front and back of the test sample and two edge views are shown. In the front view (Figure 4a), the formation of red rust on the

A-286 CRES fastener around the center pin can be seen. In the view of the back of the sample (Figure 4b), the generalized corrosion attack on the surface of the aluminum and the more concentrated attack along the edge and adjacent to the fastener may be seen. The views of the joint area from either edge are shown in Figures 4c and 4d. The buildup of the corrosion and salt products between the composite and the aluminum plate may be seen. The deformation of the aluminum and the composite is quite evident.

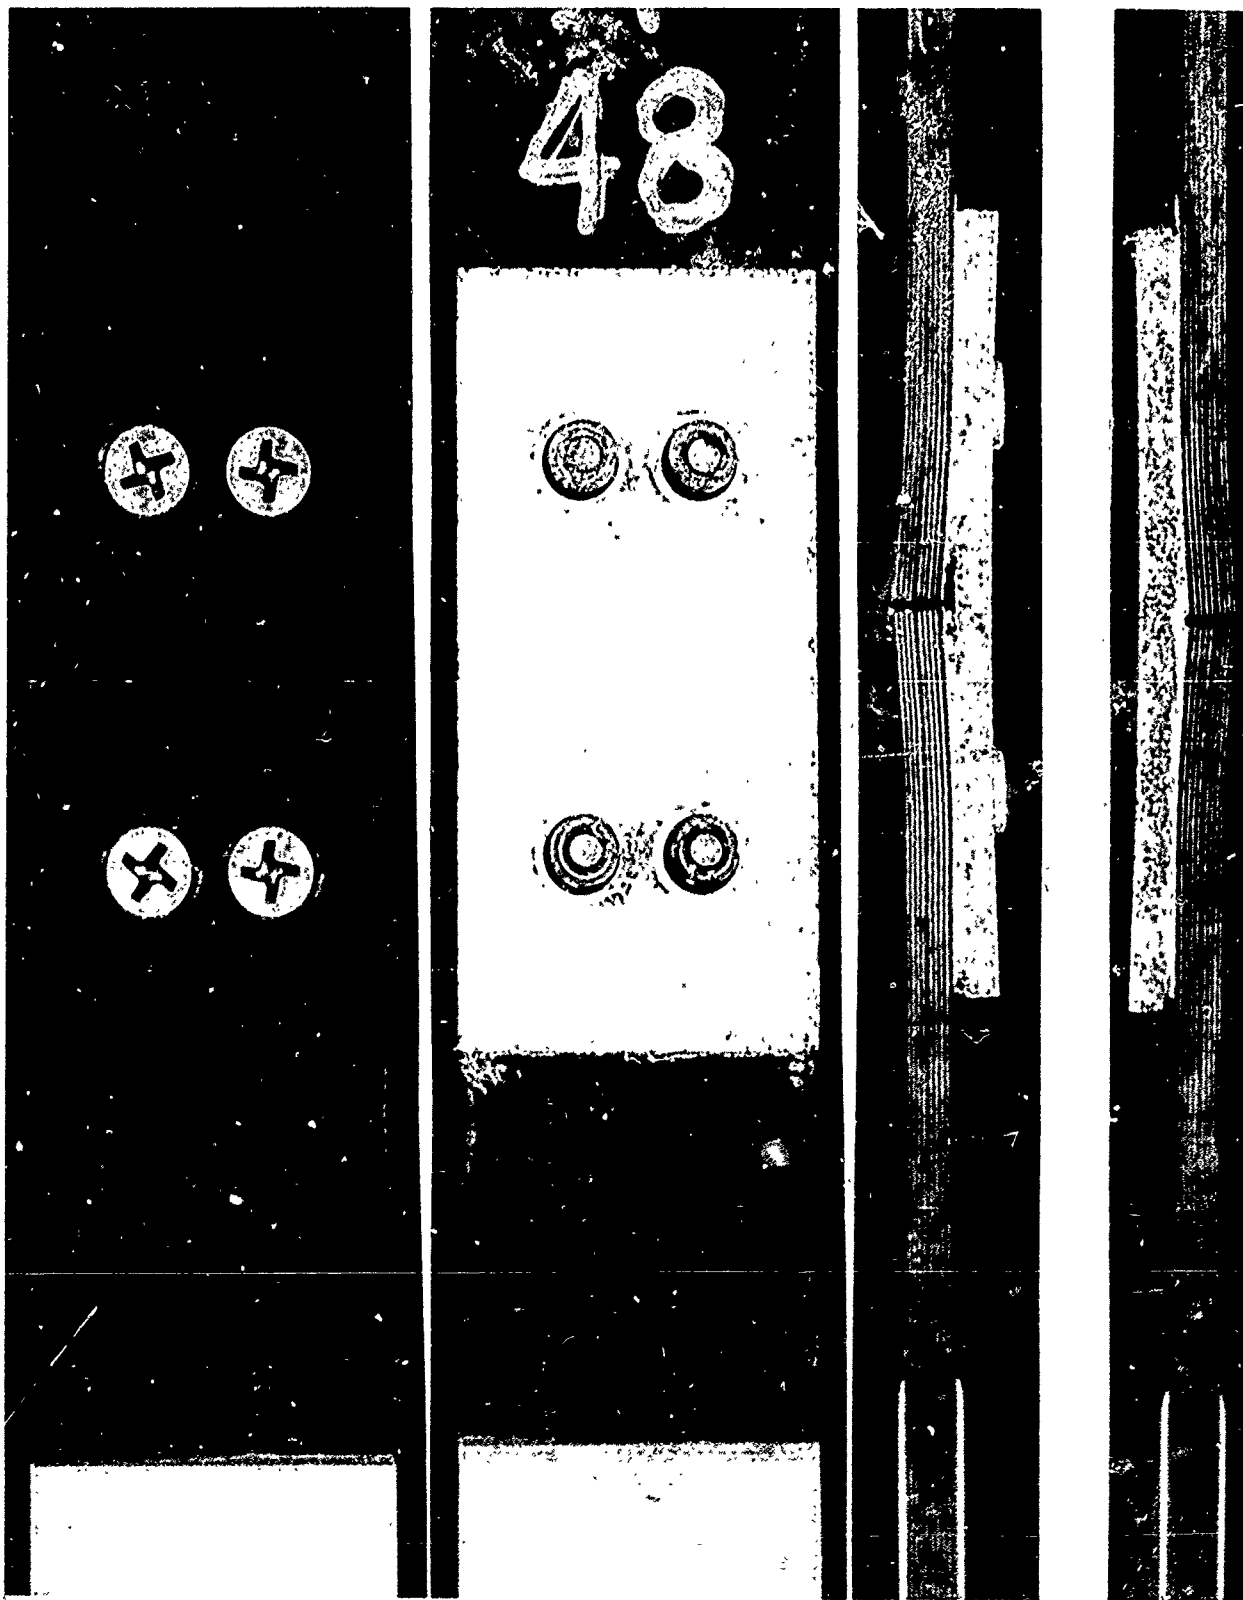
Figure 5. Unprotected Graphite/Epoxy and Aluminum Lap-Joint Fastened with Titanium Fasteners After Two Corrosion Cycles

The effect of the corrosive exposure on the unprotected composite joints with titanium fasteners is shown in Figure 5. In the front view (Figure 5a), the titanium fastener, as expected, showed little effect of the corrosive exposure. In the rear view (Figure 5b), the generalized corrosion of the aluminum may be seen. In the edge view (Figures 5c and 5d) the severe pitting of the edge of the aluminum may be seen. The buildup of the corrosion and salt products under the composite, in the area where the composite portions of the sample butt together, caused the ends of the graphite epoxy composite to bow up.

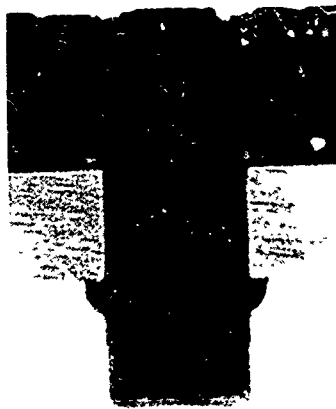
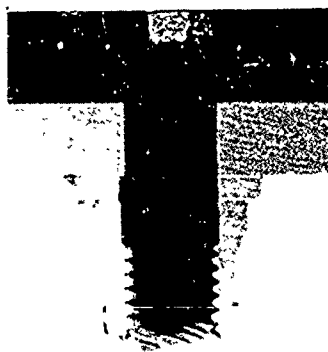
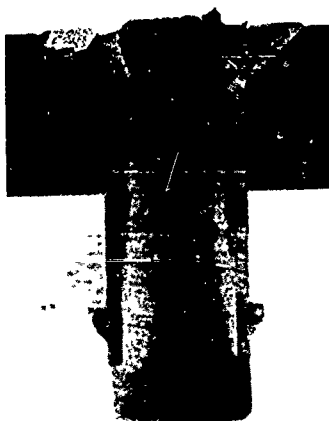
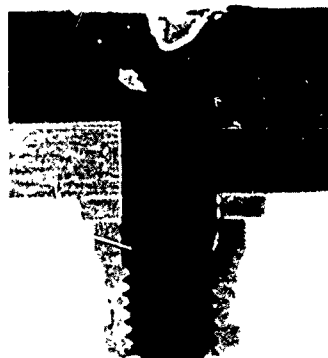
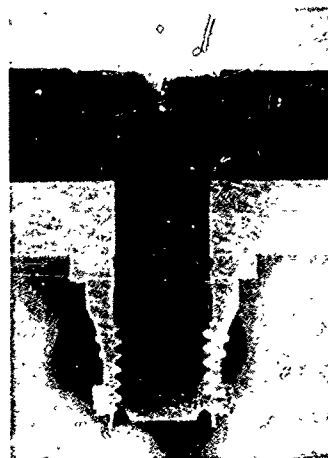
Figure 6. Protected Graphite Epoxy and Aluminum Samples, Fastener and Hole Condition After Two Accelerated Corrosion Cycles

In general, the fastener holes appear to be totally free of corrosion. The faying surface sealants adjacent to the fastener hole appear to be in good shape. Sealant is still visible in the countersunk area between the hole surface and the head of the fasteners. The dark area, which can be seen on the composite, adjacent to the fastener hole, on samples A-81, A-82, A-126, A-128, A-129, is a result of poor drilling technique. A discrepancy appearing in the photos in Figure 6 is the peeling of the top coat on the fastener heads. This did not occur during testing but was a result of the cutting process during pre-

Note, on samples A-82 and A-84 some signs of red rust are beginning to appear around the center pin of some of the CRES A-286 fasteners. This appears to result from either the paint chipping or the paint not covering a sharp corner on the fastener head.

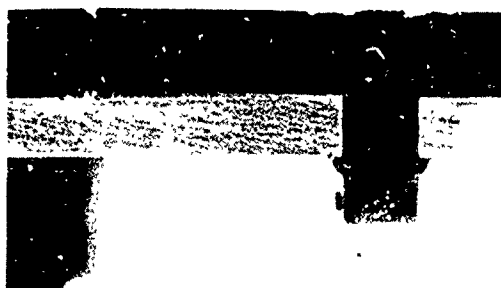
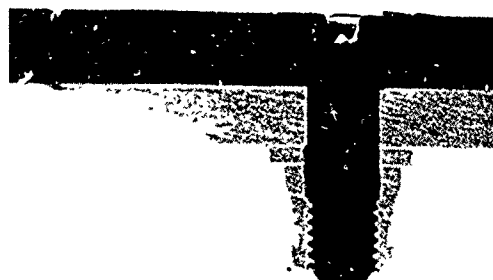
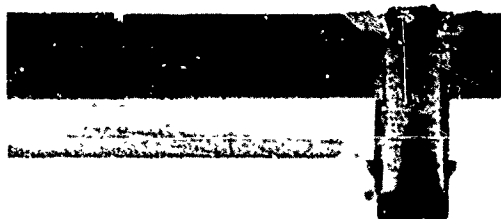
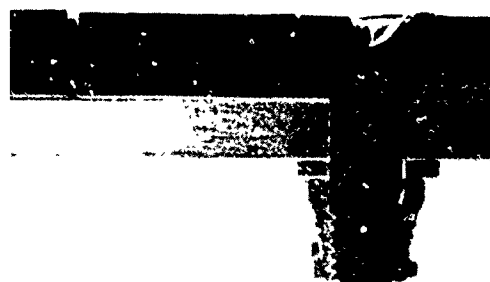
Figure 9. Protected Graphite/Epoxy and Aluminum Samples, Fastener and Butt Joint Conditions After Two Accelerated Corrosion Cycles

fastener hole and butt joint are both visible. Again, let it be emphasized that these six samples were chosen at random. Of the six samples, all six show little to no squeeze-out of sealant between the ends of the composite portion of the structure. As a result of this, three of the samples show slight to moderate pitting corrosion, the whitish area at the base of the joint, in this area of the structure.

Any faying surface disbond, samples A-81, A-84, A-128 and A-129, is a result of torque-up of the sample during fastener installation and lack of adequate faying surface sealant. This brings to light the importance of having proper sealant squeeze-out if the structure is to ever be protected from corrosion.

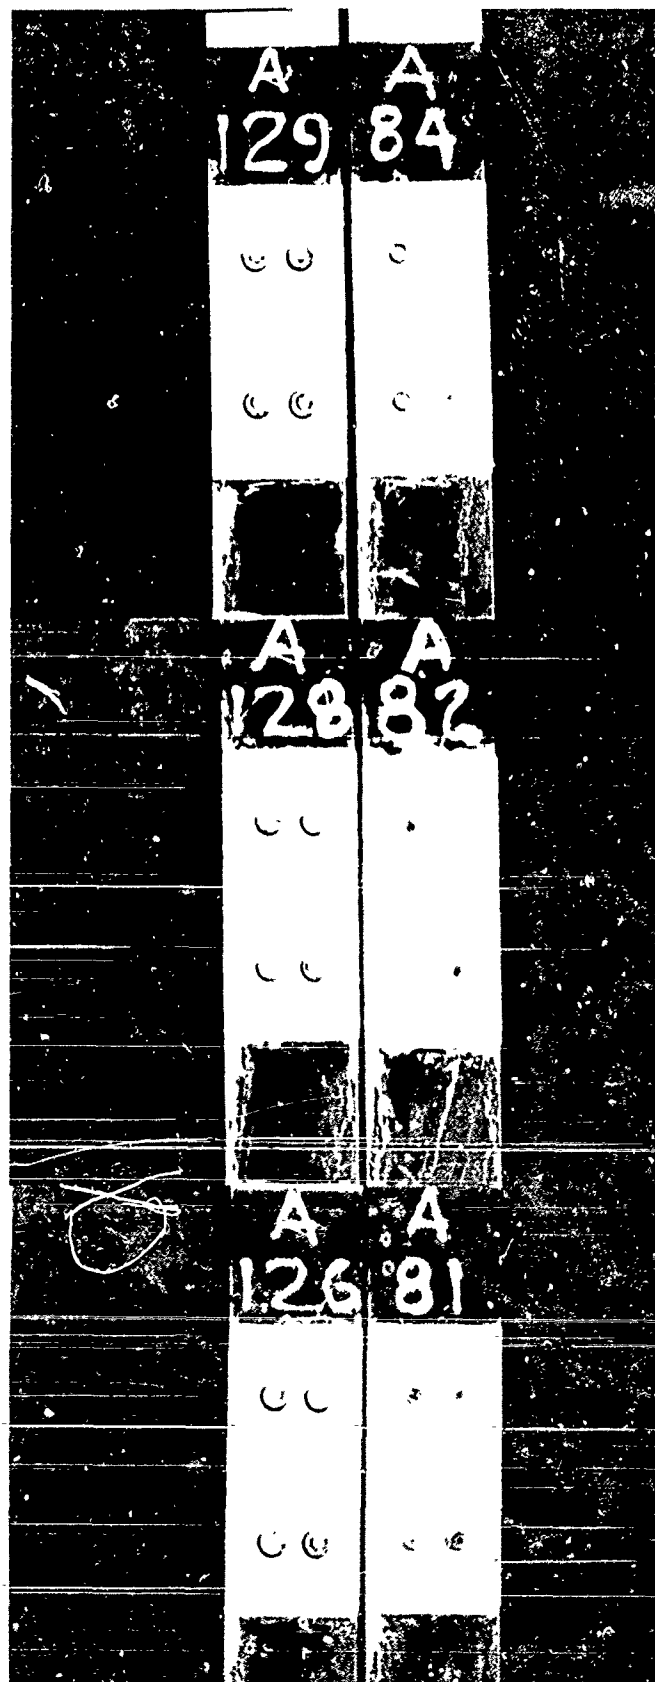
Figure 10. Protected Graphite/Epoxy Aluminum Samples, and Aluminum Structure Condition After Two Corrosion Cycles

applied by the fastener during crimping, 3) no primer coating is 100% perfect, and 4) aluminum is very anodic to steel, thereby resulting in a large electrolytic dissimilarity producing the necessary driving force for the initiation of galvanic corrosion. Couple these possibilities with the fact that this area is ideally designed to hold salt and moisture, even after the sample is rinsed off, then this frequent occurrence of corrosion in this area is not surprising. Few such observations were seen on the sample which used titanium fasteners, probably because sealant was able to be squeezed out between the washers and aluminum structure during assembly. This would result in a well sealed interface and no damage to the protective primer on the aluminum. The above observations are better illustrated in Figure 9. This figure shows the substructure of all six samples, before they were cut into. Note the lack of corrosion products at the base of the titanium fasteners while every A-286 fastener shows some degree of corrosion pitting at and around the base of the fastener, at the substructure-fastener interface.

Another observation which can be made from Figure 10 is the presence of pitting corrosion on the aluminum collars used with the titanium fasteners. This was observed on every sample using titanium fasteners. The reason for this is due to the large electrolytic dissimilarity between titanium and aluminum. This dissimilarity produced a galvanic couple resulting in corrosion pitting.

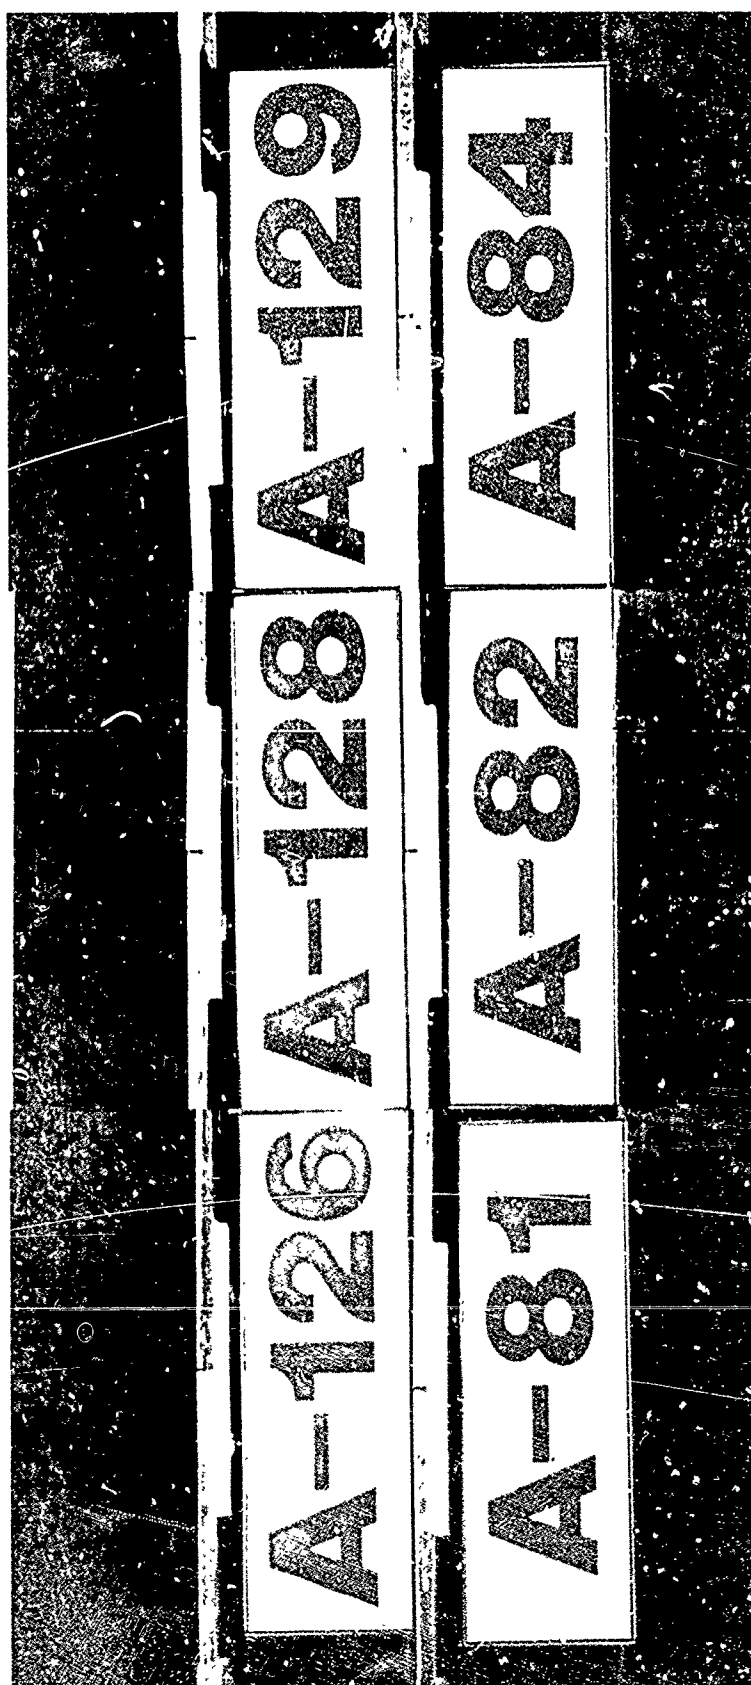
Figure 11. Protected Graphite/Epoxy and Aluminum Samples,
Structure Edge Condition After Two Corrosion Cycles

Another significant observation made was the occurrence of moderate to severe pitting corrosion along the edge of the aluminum substructure. In this area it was obvious that the aluminum was going to be in very close proximity to graphite fiber ends, which were exposed along the end edge of the composite structure. It was felt at the start of this program that such an area as this would be very vulnerable to corrosion when subjected to a corrosive environment. It therefore was decided that the edges of the composite structure, on some of the samples, should be painted so that a comparison could be made. Figure 11 presents photos of the edge of the six samples which were selected from this group. It can be seen that all six samples experienced some degree of pitting along the edge of the aluminum. This was typical of all the samples tested. As can be seen A-129 was one of the samples which had the edge of the composite painted. This reduced, but did not prevent, corrosion from occurring. Another significant point to consider is the fact that the aluminum alloy used was 2124-T851, which is supposed to be a more corrosive resistant aluminum alloy than the 2024 series. Also the substructure was chromic acid anodized and covered with two coats of epoxy primer (MIL-P-23377). Such protective steps only reduce the chance of corrosion occurring. However, no paint, primer, or anodize layer can be 100% perfect; therefore, the chances of totally preventing corrosion are slim.

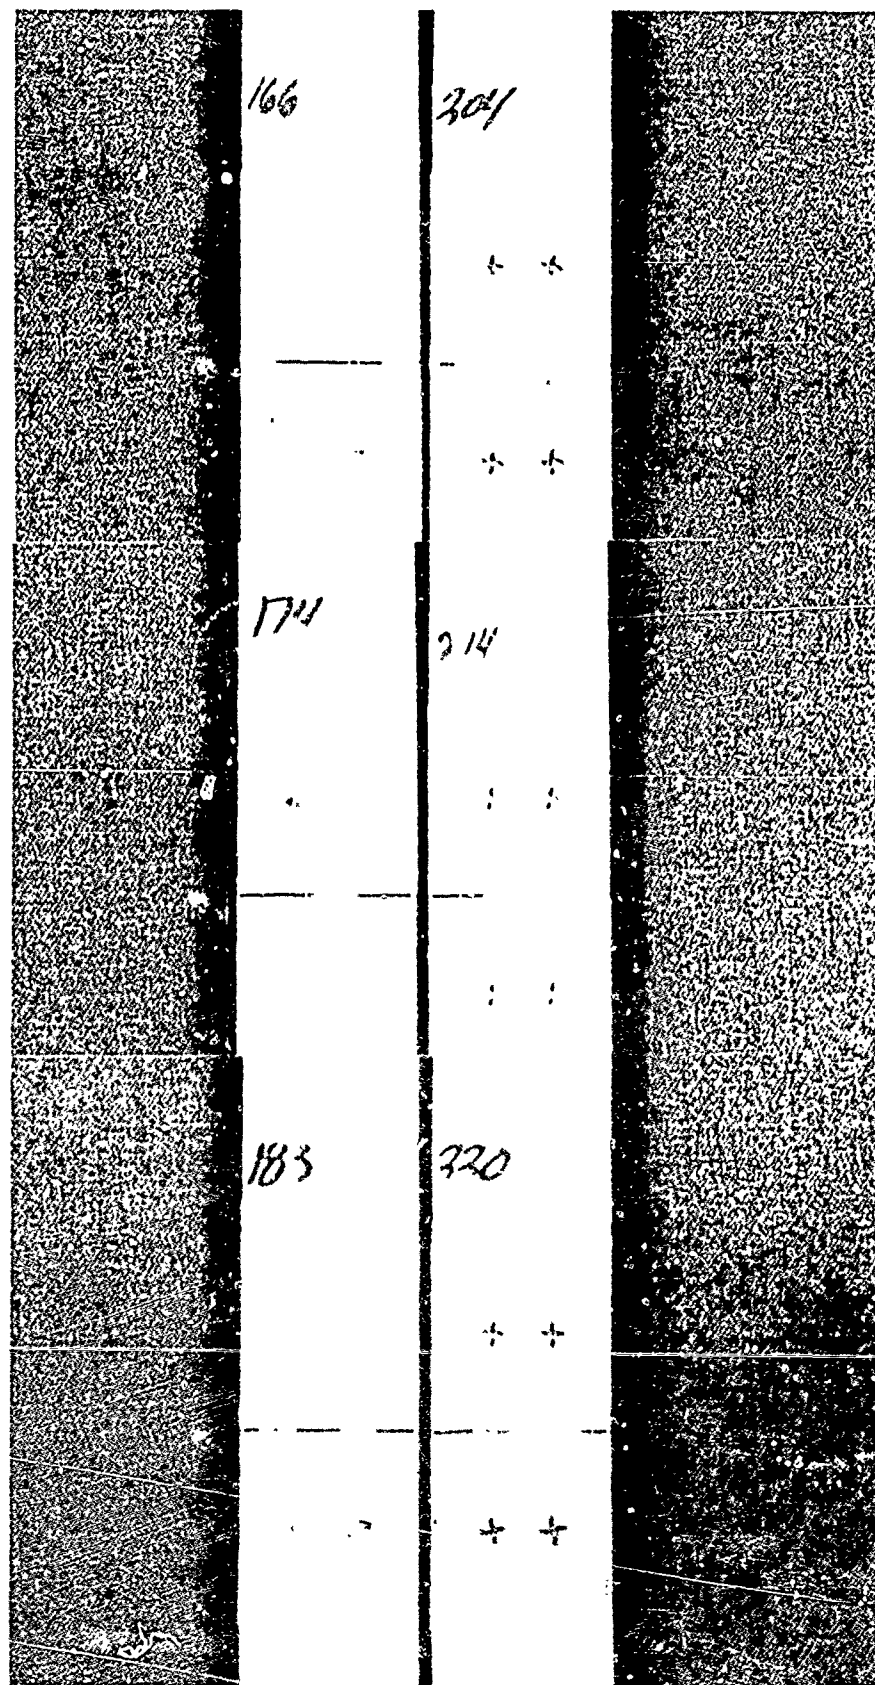
Figure 12. Protected Graphite/Epoxy and Aluminum Samples, Top Surface Condition After Two Accelerated Corrosion Cycles and One Fatigue Cycle

As can be seen in Figure 12, the upper surface of these samples, typical of all fifty samples, appear in good shape, except for the red rust products on some of the A-286 fasteners. The top coat appeared to have withstood the structural loading without cracking or peeling.

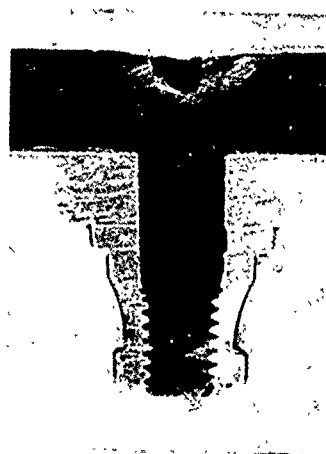
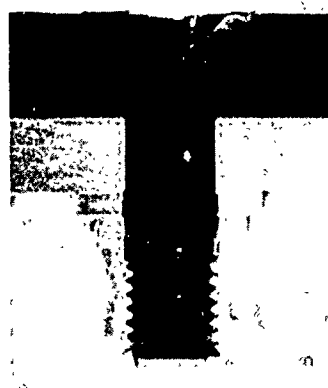
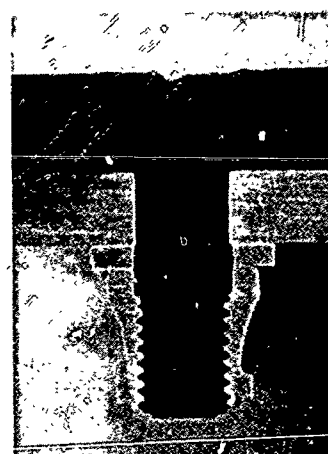
Figure 13. Protected Graphite/Epoxy and Aluminum Samples, Fastener and Hole Condition After Two Accelerated Corrosion Cycles and One Fatigue Cycle

samples, in this area, was identical to that seen in the samples which underwent accelerated corrosion testing only. It appears that the fatigue loading did not produce any cracks or deterioration in the protective coatings and sealants around the fasteners. Of course this is a function of load level and if the applied loads had been higher the response may have been different.

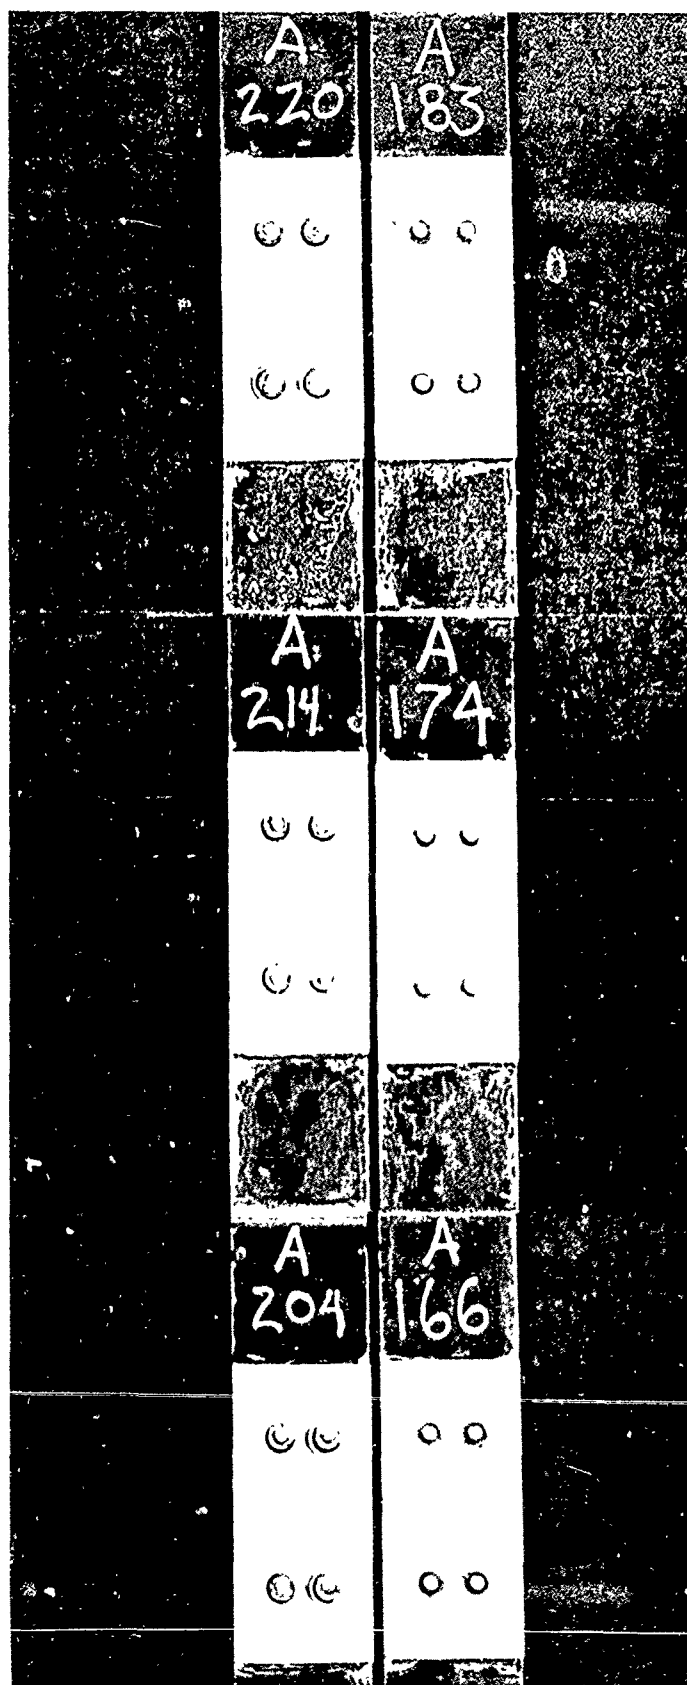
Figure 14. Protected Graphite/Epoxy and Aluminum Samples, Aluminum Structure Condition After Two Corrosion Cycles and One Fatigue Cycle

As noted before, these samples also showed severe pitting at the location of crimping on the samples using A-286 fasteners. Also, as noted before, the aluminum collars used on the titanium fasteners show signs of severe pitting. Figure 14 presents a series of photos which show the backside of these six samples showing these areas of corrosion. Figure 15 shows enlarged views of the same fasteners shown in Figure 13 but the butt joint area and faying surface bondline are also shown. As can be seen in these photos, samples A-174, A-183, A-204, A-214, and A-220 show that there was more than adequate squeeze-out of sealant in the butt joint area. However, sample A-166 had very little squeeze-out and, as can be seen, all samples show no signs of corrosion in this area.

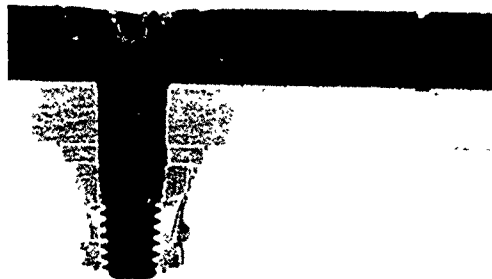
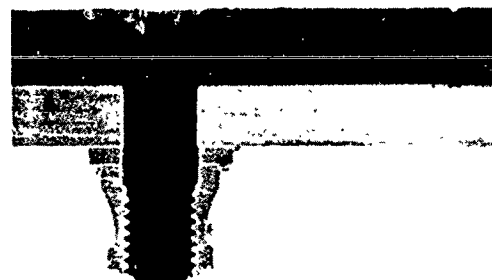
Figure 15. Protected Graphite/Epoxy and Aluminum Samples, Fastener and Butt Joint Condition After Two Accelerated Corrosion Cycles and One Fatigue Cycle

Note the large cracks appearing in the sealant in the joint area. These cracks appear to have resulted due to sealant curing then aggravated by the structural loads which were applied during fatigue cycling. This is evident by the smaller cracks in the sealant adjacent to the aluminum substructure and the corner of the composite skin structure. This appears on all six samples

and if left undetected on actual aircraft structure could result in increasing the structure's vulnerability to corrosion. The sealant (MIL-S-83430) is the type presently being used on the faying surface on many aircraft which have composite-aluminum structure.

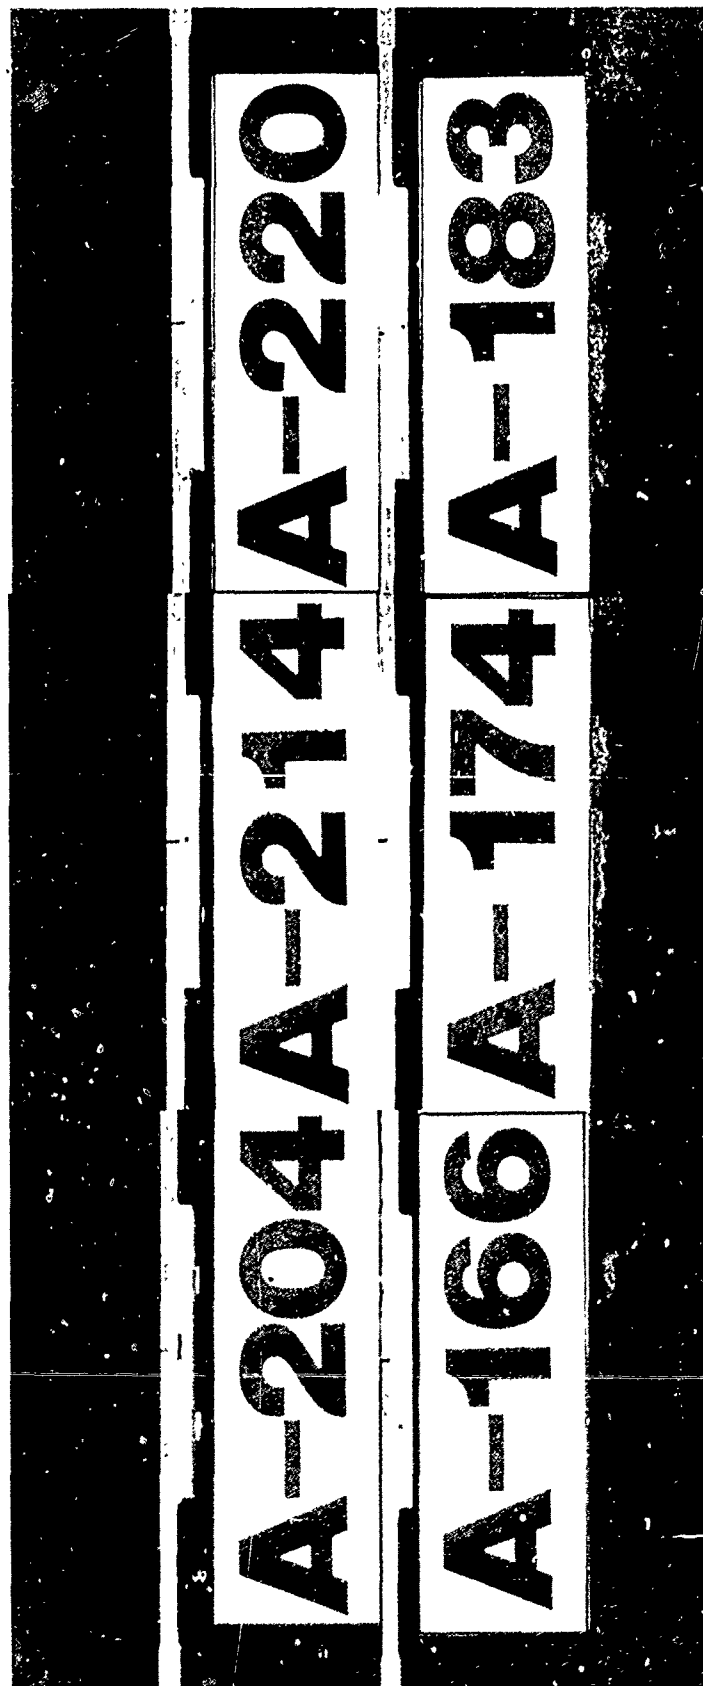
Figure 18. Protected Graphite/Epoxy and Aluminum Samples, Structure Edge Condition After Two Corrosion Cycles and One Fatigue Cycle

Figure 18 is a series of macrographs showing the edges of the six samples A-166, A-174, A-183, -204, -214, and A-220. As can be seen in these photos, the edges of the composite structure were covered with polyurethane top coat. However, this did not prevent the occurrence of corrosion. The corrosion response of this portion of these test samples was very similar to that of the samples which did not undergo load cycling.
